HOME INSPECTION REPORT

1234 School House Road
Yourtown, US 12345

Prepared for: Bob Smith

Prepared by: Dexaco Home Inspections
1140 Jessamine Lake Court
Orlando, FL 32839
www.dexacohomeinspetions.com
www.my-orlando-home-inspection.com

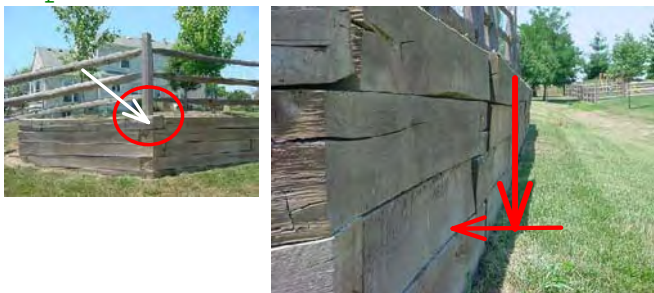
1. Vegetation: Shrubs with some weeds
2. Retaining Walls: Railroad ties The wall is showing signs of movement, but appears to be stable at this time. A qualified contractor is recommended to evaluate and estimate repairs to maintain the wall.

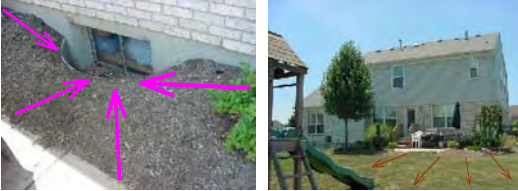
1. **Deck:** Treated wood The deck has been built below acceptable building standards and is not safe in its current state. Recommend further evaluation and estimate to bring deck up to an acceptable building standard.
2. **Grading:** Moderate slope The grade and landscaping materials are too high and extend above the window well at the Northeast rear of the home. Recommend that the grade be reduced or the metal window well soil retainer be replaced with a taller unit to keep the mulch and soil beds from washing into the well.

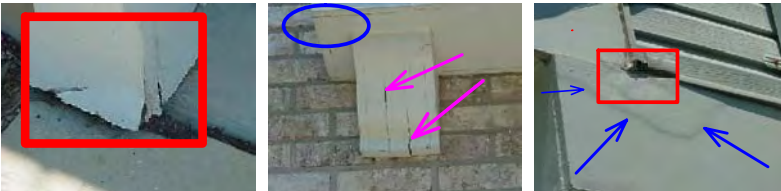
1. Water damage to trim wood at either side of garage door from moisture wicking into the finished particle board. The surface is starting to delaminate. Recommend repair/replacement of the trim boards and silicone seal wood that is in contact with concrete to prevent wicking.

2. The wood window boxes have water damage and will require repair/replacement. The wood has started to separate at the supports and at the corners of the window boxes.

3. The trim board at the southwest corner of the porch has water damage due to water penetration and will require repair/replacement of the wood. The trim board extends out creating a ledge allowing water to collect on the top edge of the board and cause the wood to rot.

Recommend estimate/repairs by a qualified contractor.
